Report on the investigation of
the grounding of the sail training vessel

TS Royalist

5 April 2009

Report No 26/2009
December 2009

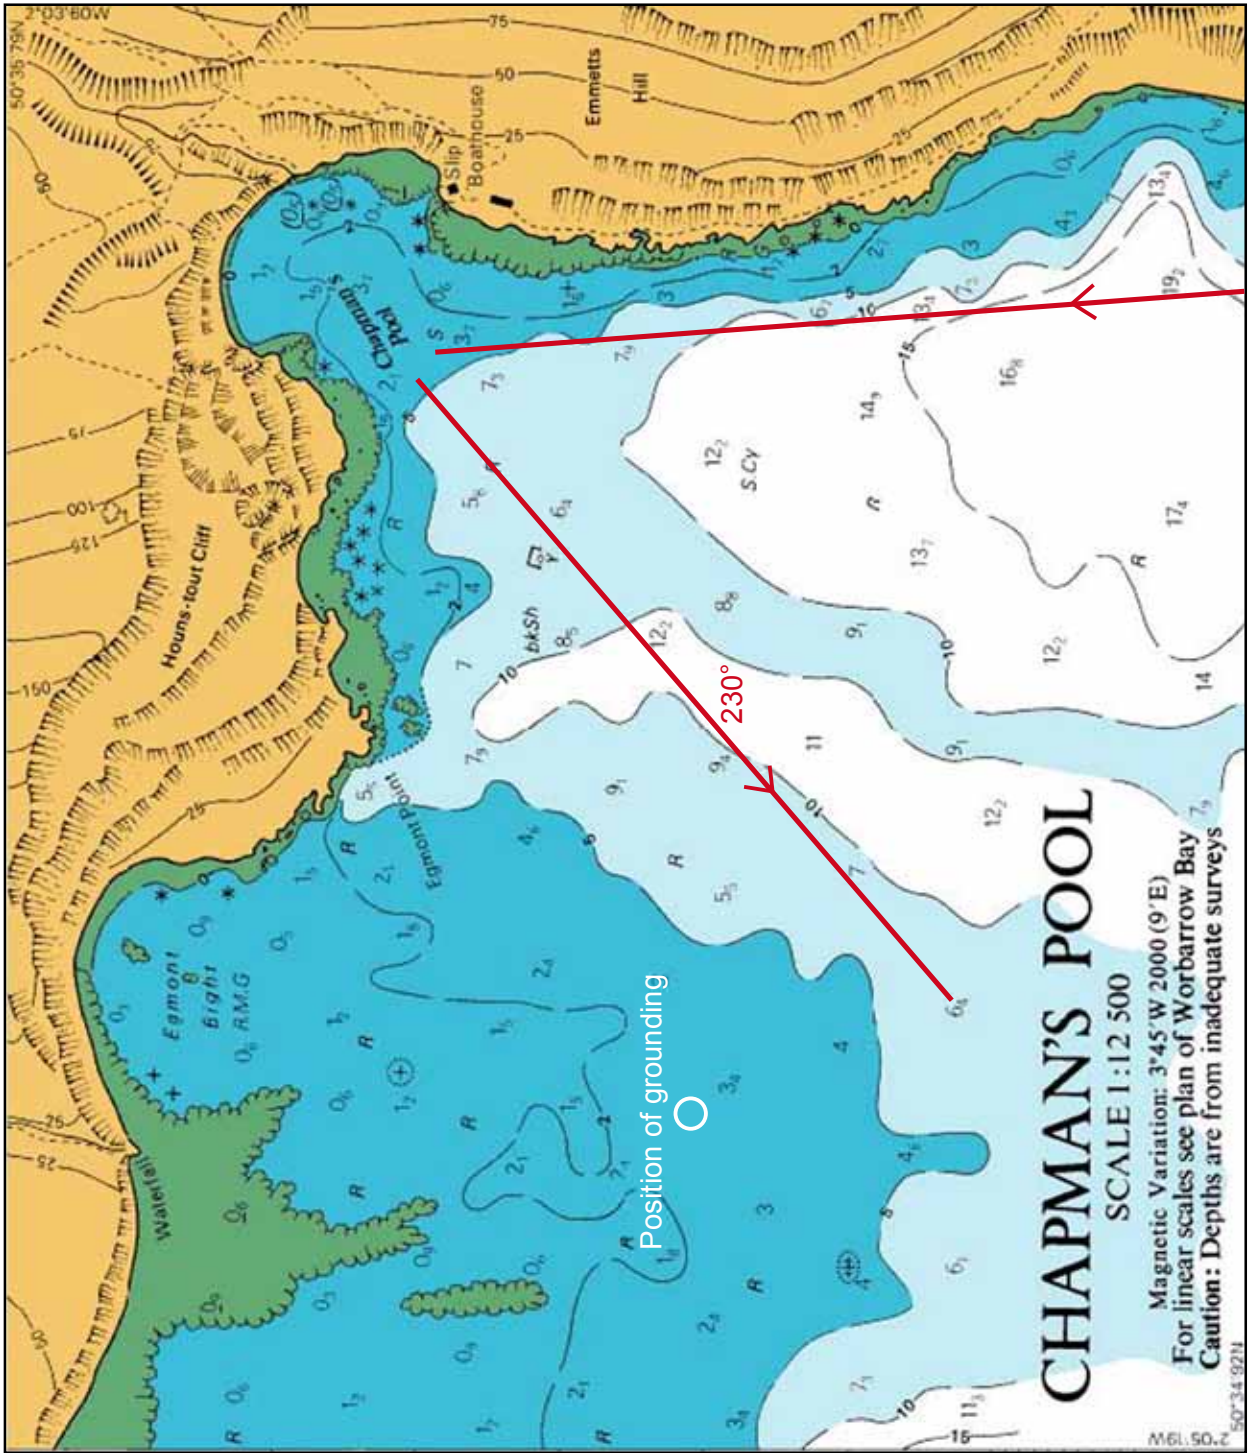
Basic interpretation of intended track to and from Chapman's pool and position of grounding

At 1120, the vessel grounded in a position approximately 2 cables to the north-west of the master's intended track. The master ordered the engines to be stopped and the sails to be furled.

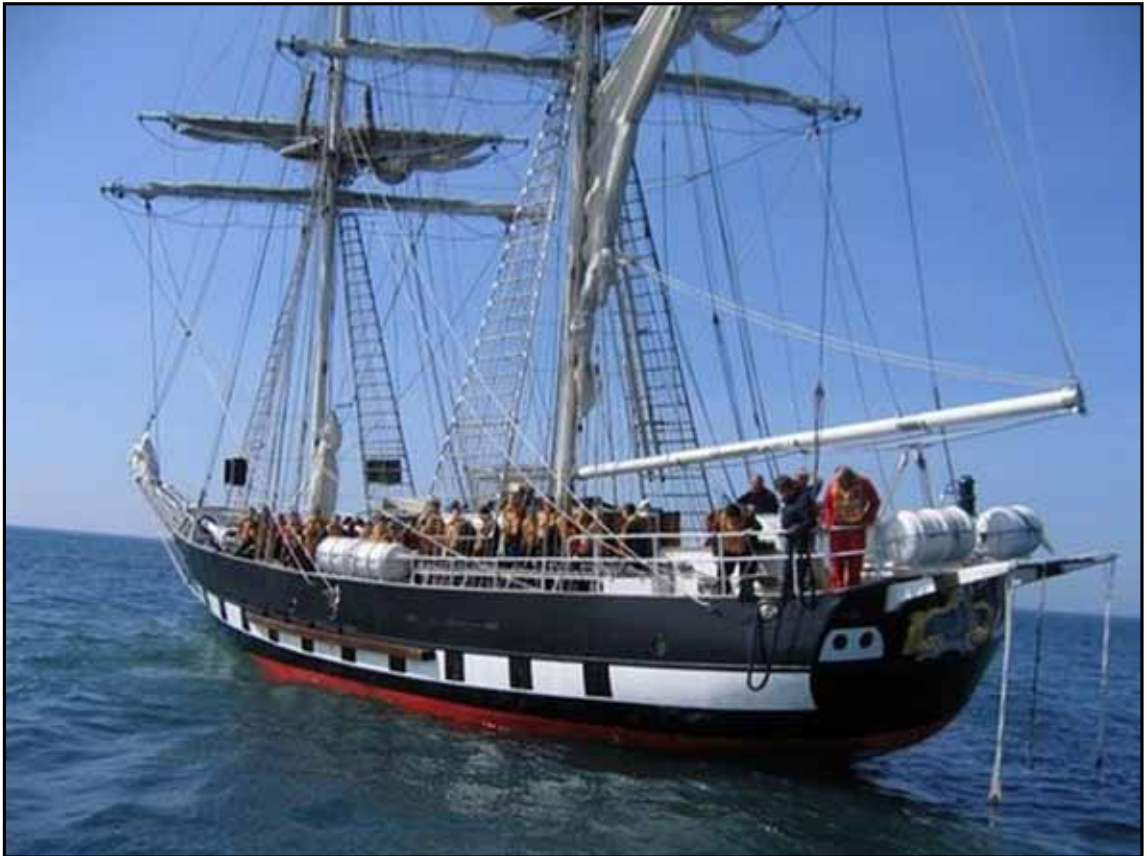
The master made a brief attempt to refloat the vessel using astern power; however, the vessel remained fast aground. It was an hour before low water, with 0.1m of tide still to fall. On the master's instruction, the coxswain launched the tender, and stood by off the vessel.

TS *Royalist* aground off Chapman's Pool

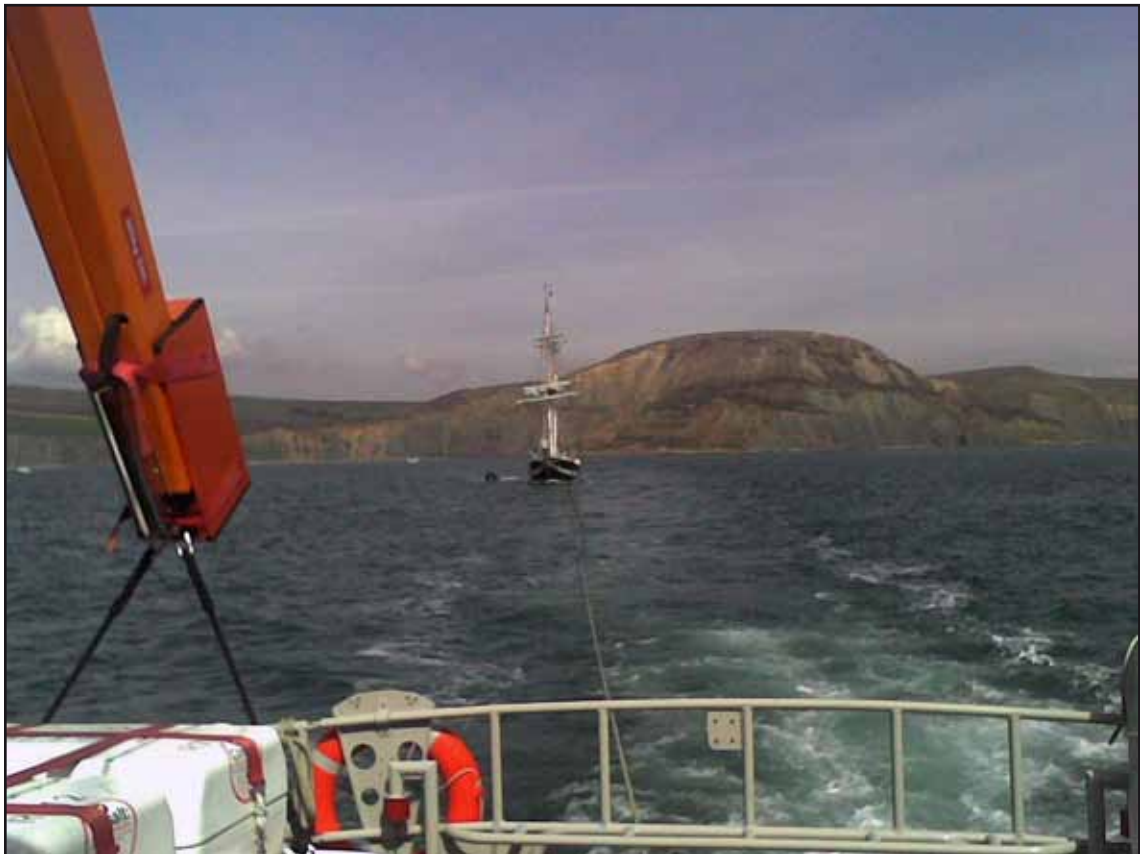
Flying Cloud passed the lifeboat's towline to TS *Royalist*'s port bow, and the kedge anchor line was released and buoyed. In accordance with the advice provided by the lifeboat crew, the cadets were sent below before the lifeboat put weight on the towline. TS *Royalist* refloated at 1252 (**Figure 5**). The permanent staff checked all internal compartments again, and tested the engines and the steering; all were found satisfactory.

TS *Royalist* being towed by Weymouth RNLI lifeboat

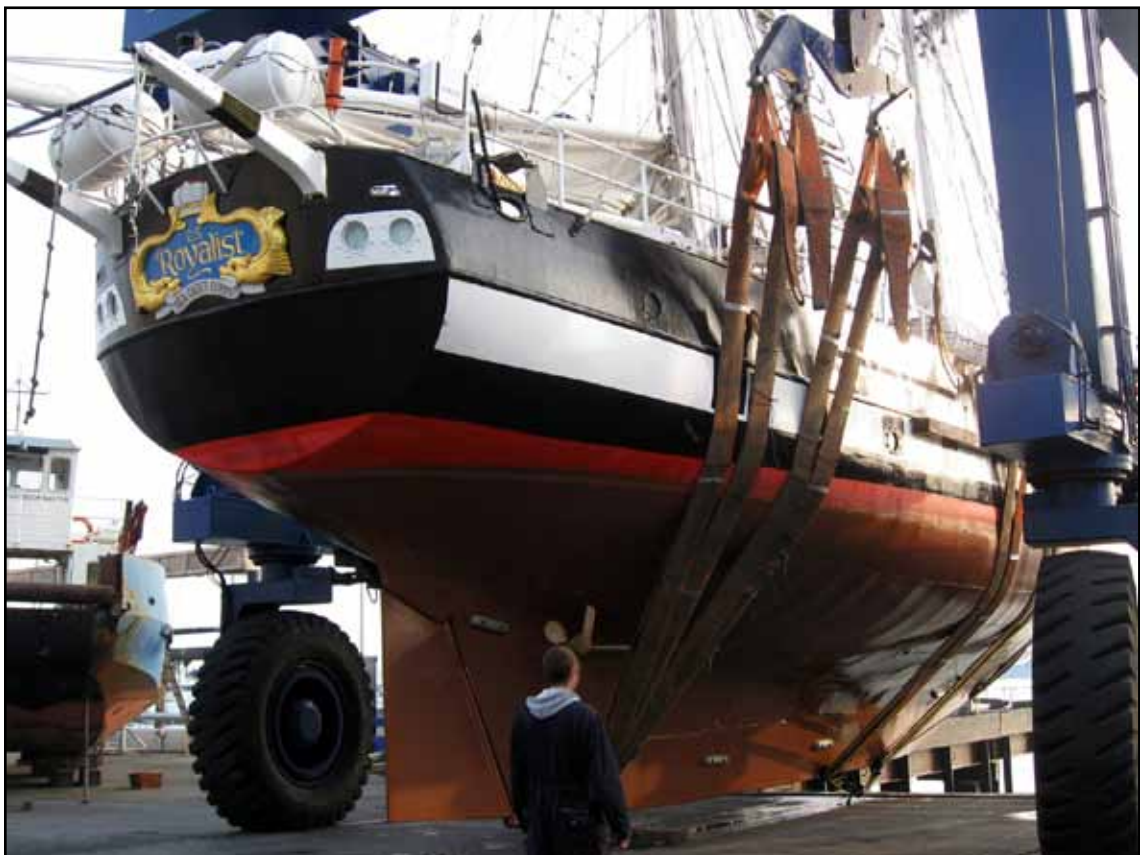
TS *Royalist* arrived at Gosport at 1915. She was lifted out of the water and, on inspection, no grounding damage, except some minor scrapes to the vessel's anti-fouling, was found (**Figures 6 and 7**). The vessel resumed her schedule the following morning.

TS *Royalist* in the lifting cradle for hull inspection after the grounding

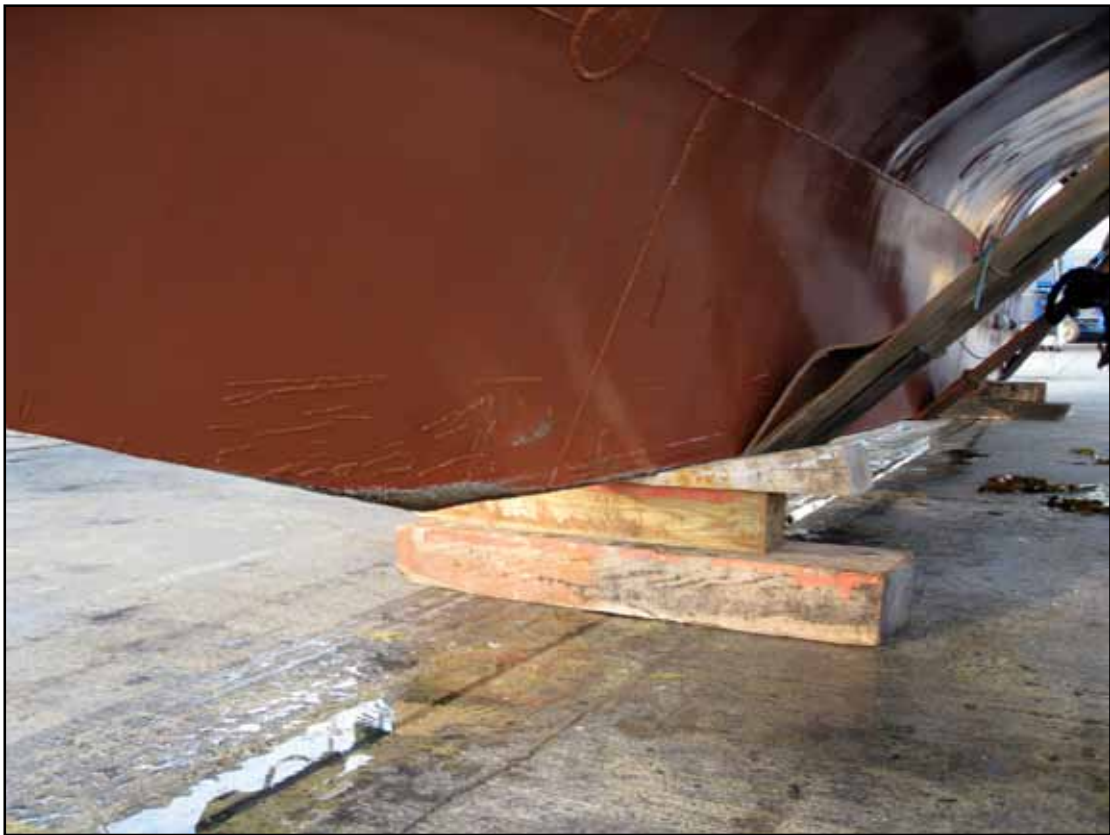
Minor scrapes to the anti-fouling of TS *Royalist*
